\$10 Million Marina Fire Bohemia Bay, Maryland

\$10 Million Marina Fire Bohemia Bay, Maryland (January 6, 1989)

Investigated by: Randolph E. Kirby

**This is Report 026 of the Major Fires Investigation Project conducted
by TriData Corporation under contract EMW-88-C-2649 to the United
States Fire Administration, Federal Emergency Management Agency.**

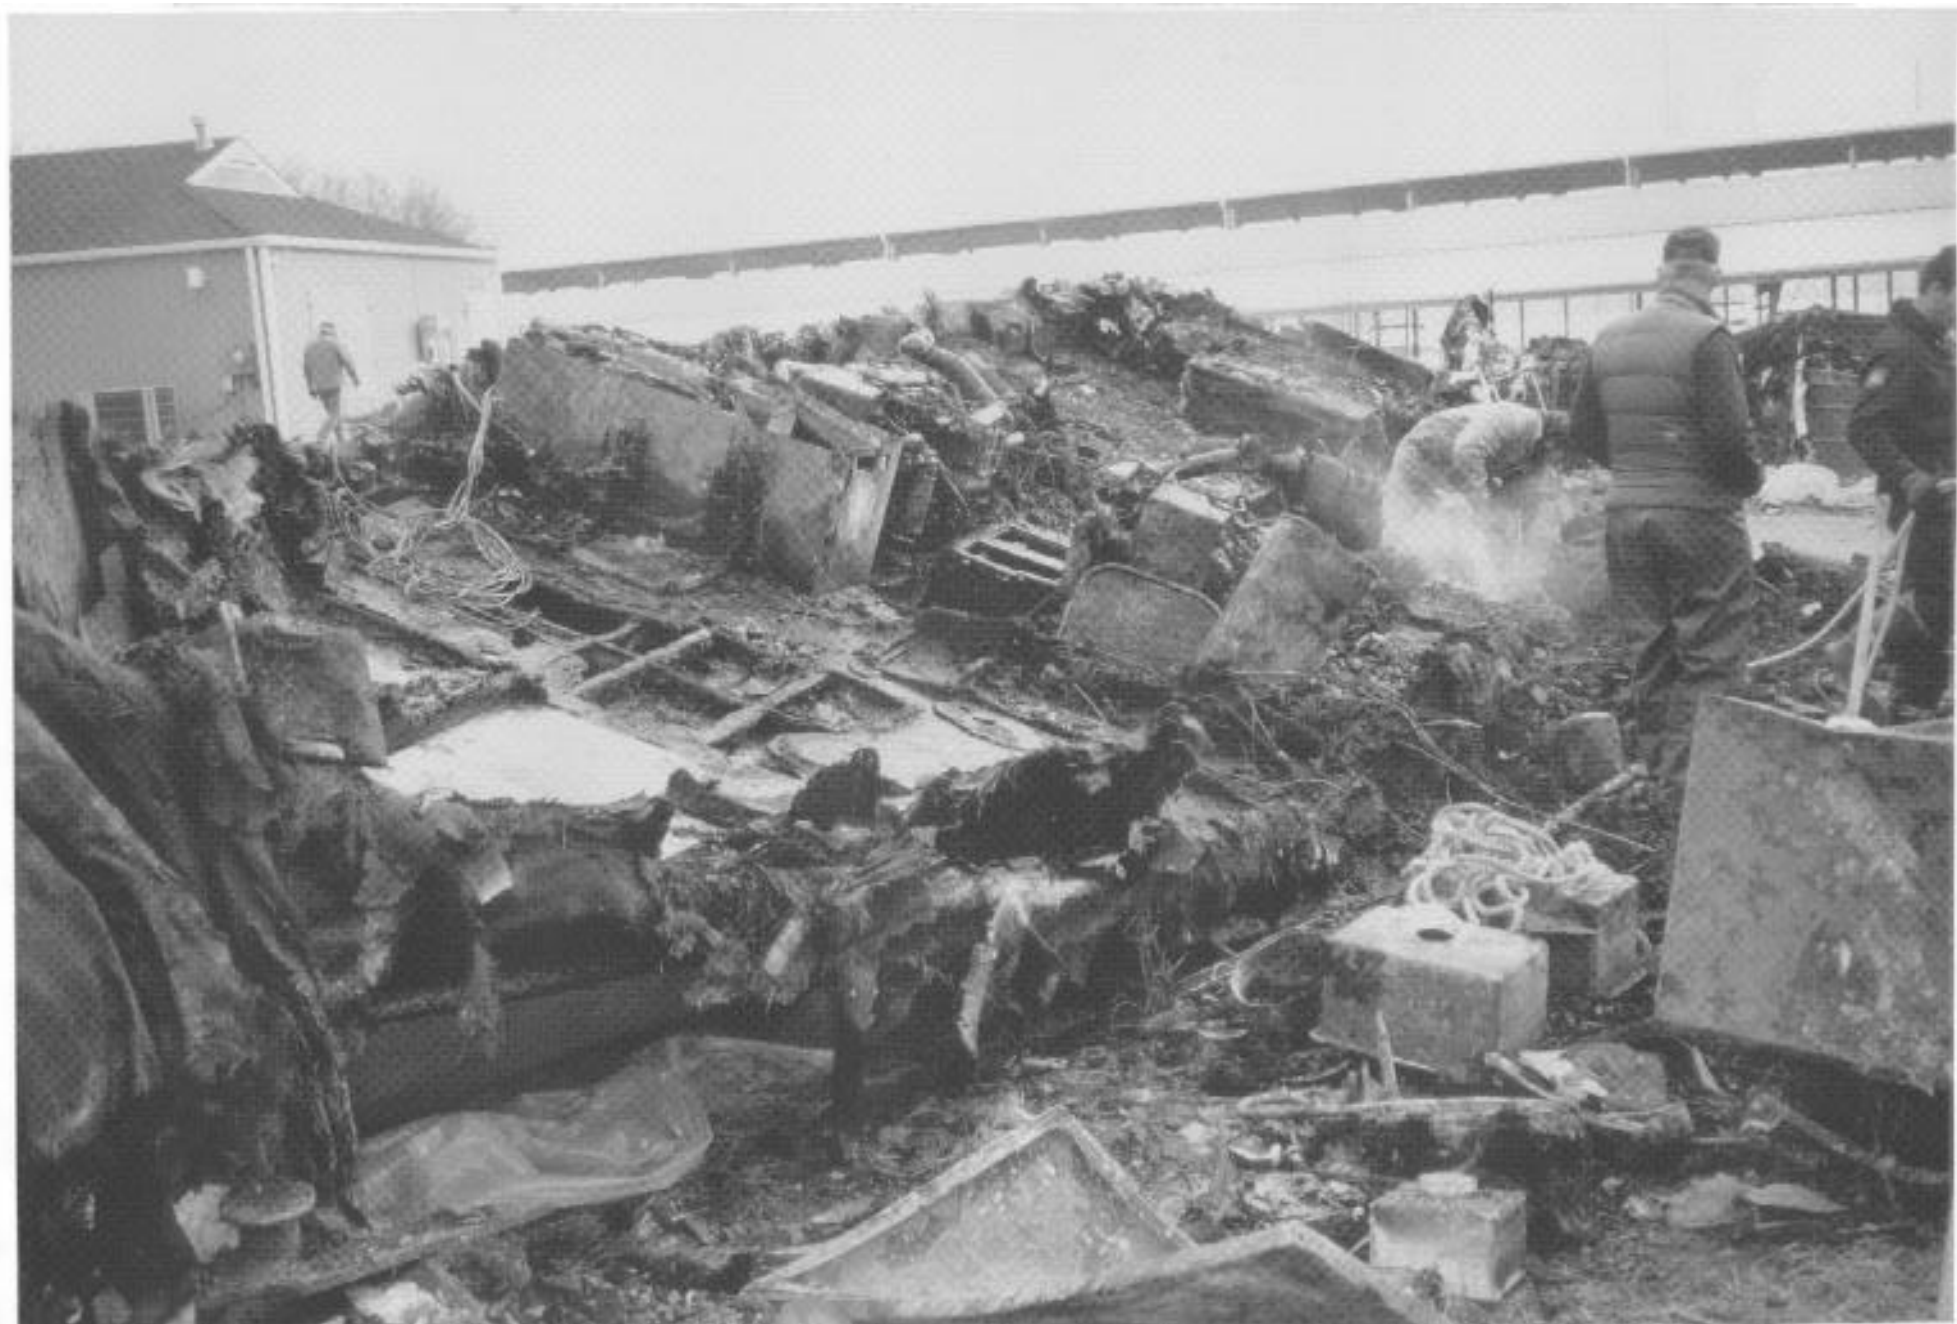
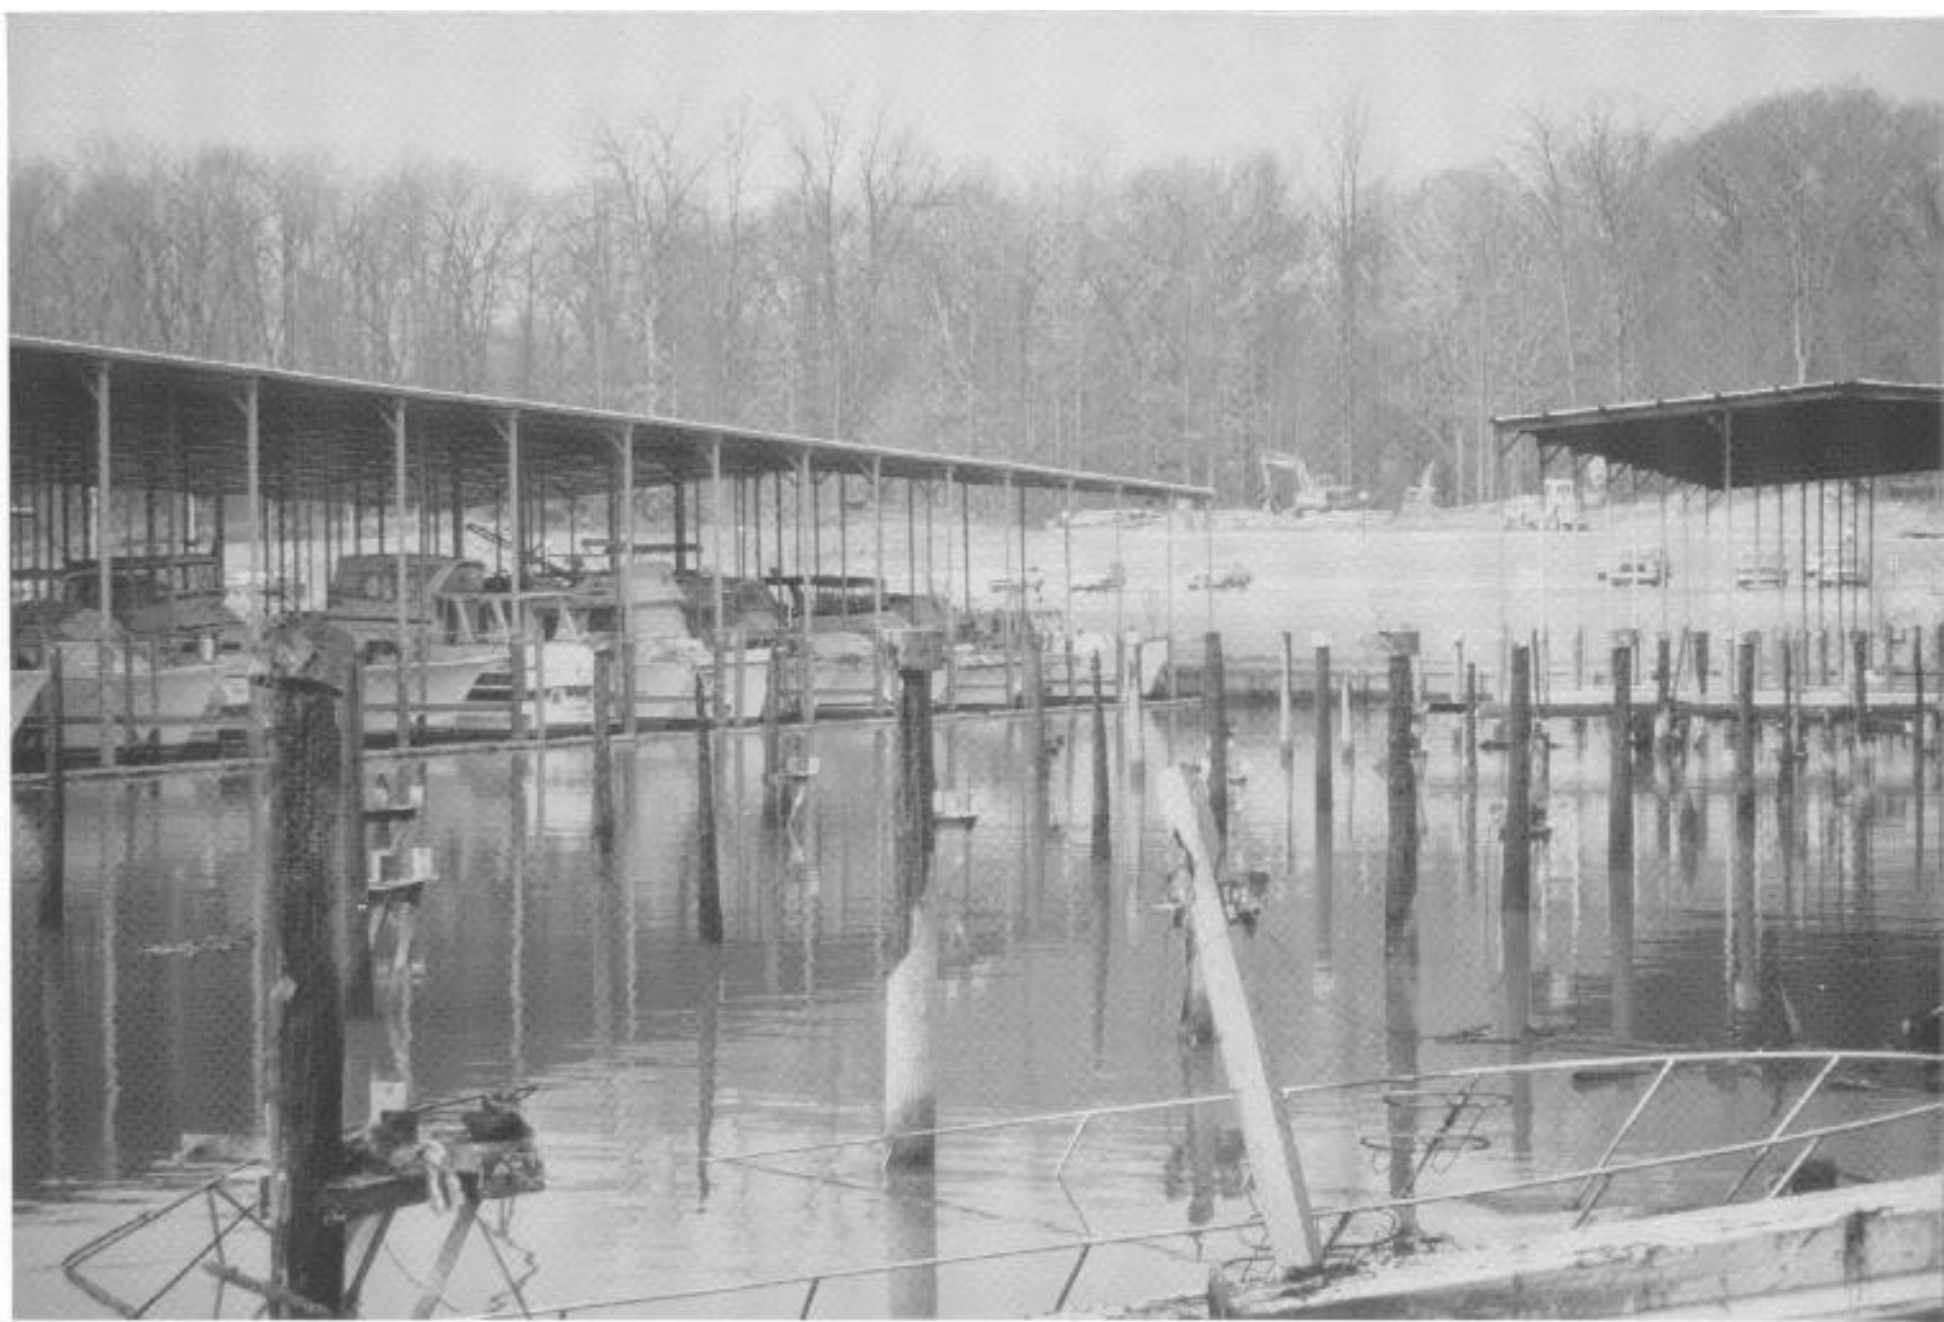
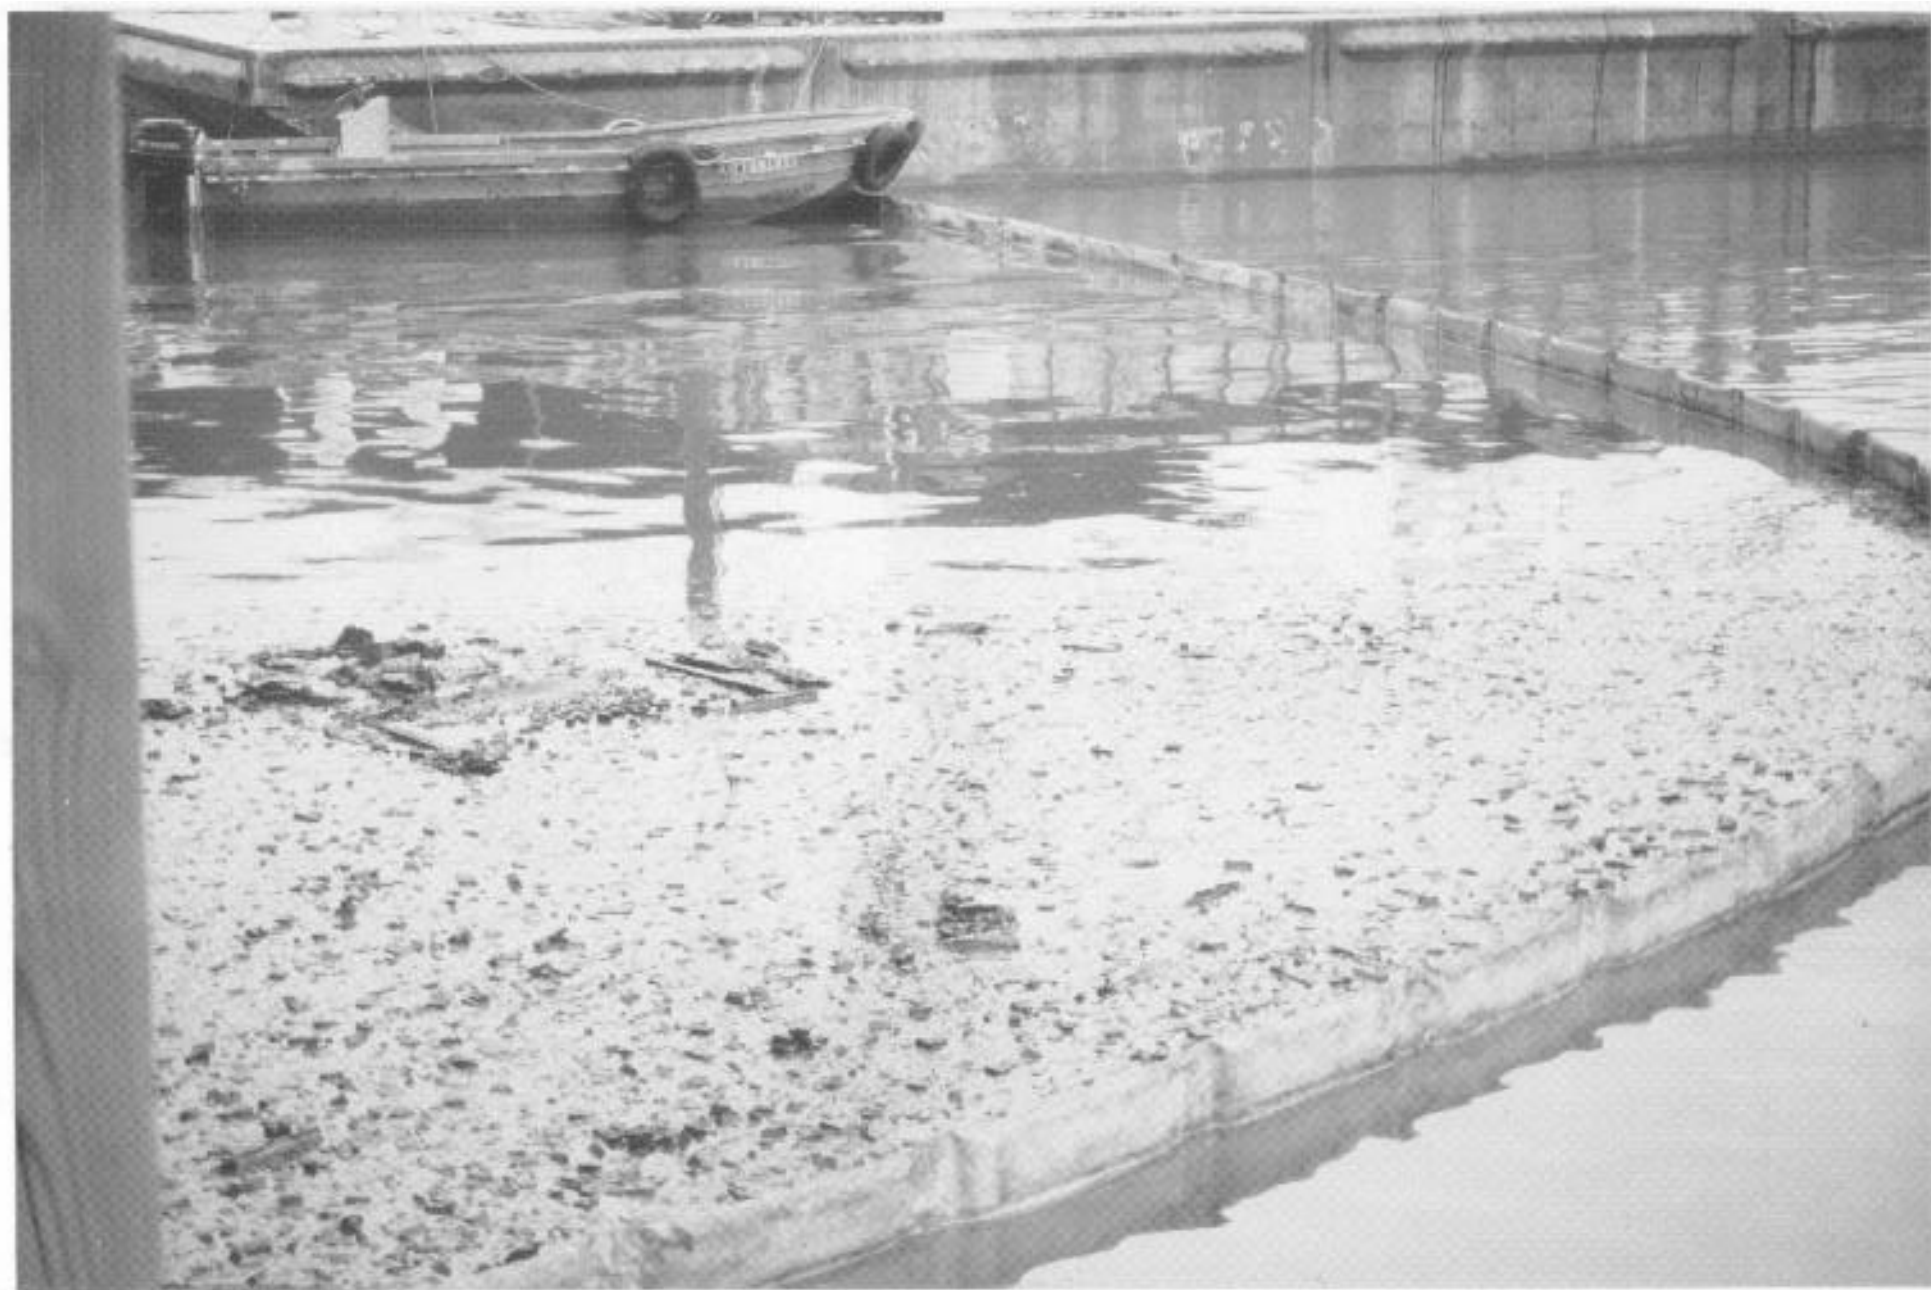
<u>Slides</u>	<u>Description</u>
1	Entrance to Bohemia Bay from Town Point Road.
2	Salvage operation - south end of 'E' dock.
* 3	Raised hull being examined by fire investigators (with boats typical of those that burned in background).

* 4	Burned piers of 'F' dock.
5	South end of 'F' dock showing sunken vessels.
6	Sunken vessel being raised amidst burned piers - south end of 'F' dock.
7	Looking south between 'E' and 'F' docks.
8	Remains of north portion - 'F' dock roof structure.
9	North portion - covered slip areas. Note sloping terrain.
10	Heavy equipment required for conducting investigation and salvage work.
11	Carport section of remaining roof structure 'F' dock.
12	Remaining carport section of 'F' dock - note restricted access.
13	Remains of wooden pier - 'F' dock area.
14	Remains of vessel after being raised.
15	Remains of 'F' dock finger pier and sunken vessel.
16	Looking south at center pier of 'E' dock.
17	Damaged pier at 'E' dock, slip 21.

* 18	Equipment used for containment ponds.

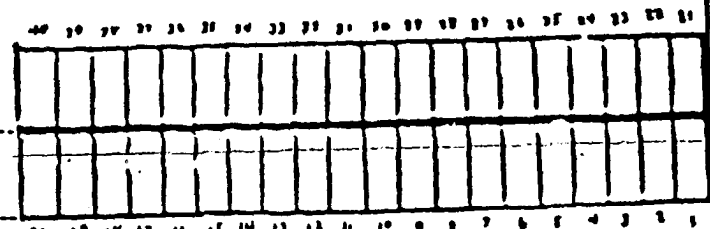
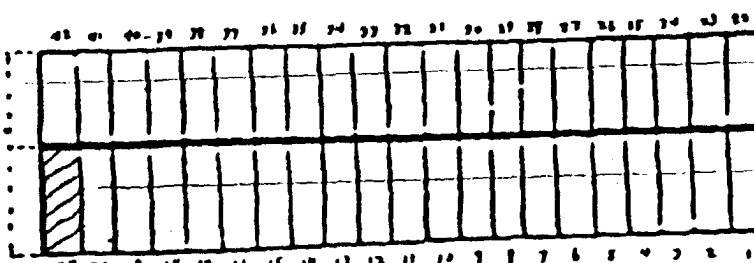
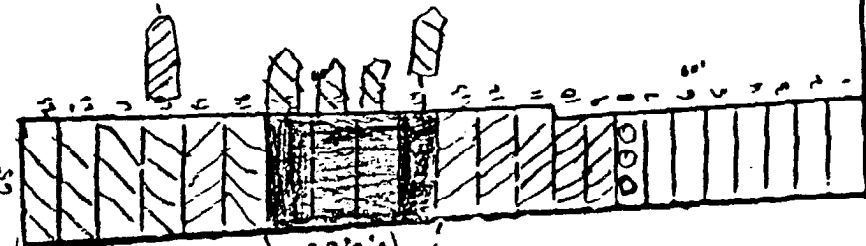
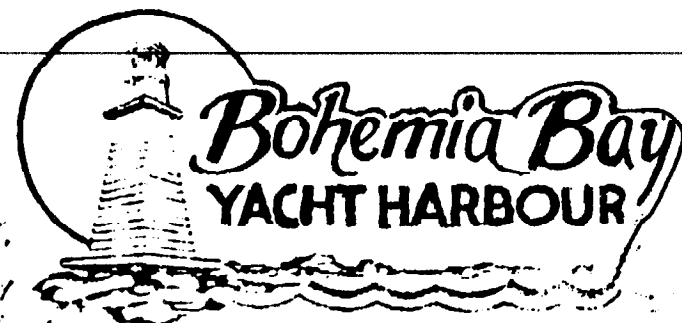
EXTENT OF FIRE DAMAGE TO Building & Docks

Approximately two-thirds of the metal structure of 'F' dock (250 feet) had to be removed before any investigative or salvage operations could begin. Even though the structure itself did not burn, the foundation was weakened and could no longer be used because of supporting piers burning.

Most of the finger piers, pilings, and walkways between slips 9 and 23 on 'F' dock were destroyed. Sixteen vessels were sunk. One vessel located at 'F' dock received heavy damage and two at 'C' dock received substantial damage as a result of fuel burning on the water. Approximately 100 boats received light damage from soot and burning embers. Their cleaning proved much more difficult and expensive than first thought.
